# Professional Inspection Report

Home Inspection - New Construction

**Property Address:** Toronto

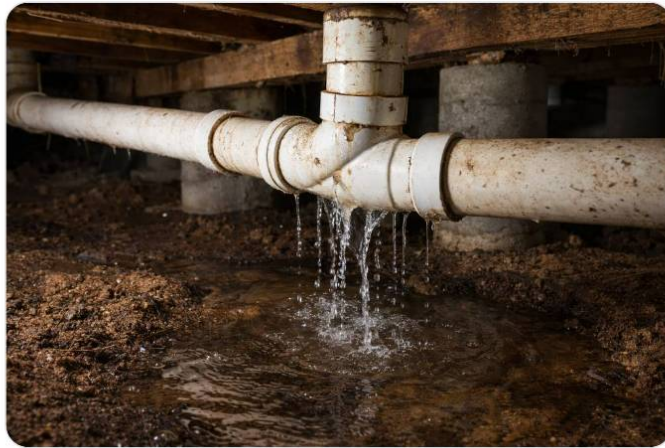
### Finding #1

Plumbing

Pipe leak

High

During the inspection, active water leakage was observed from a connection in the home's drainage pipe. Moisture and water accumulation were detected around the pipe joint, indicating a failure in the pipe connection or seal. Continued leakage may lead to moisture damage, deterioration of nearby materials, and potential mold development if not addressed.

**Repair Instructions:** It is recommended that a qualified plumbing technician inspect the affected drainage section and repair or replace the damaged pipe connection. The repair should include sealing or replacing the faulty joint and verifying that the drainage system is functioning properly without further leakage.

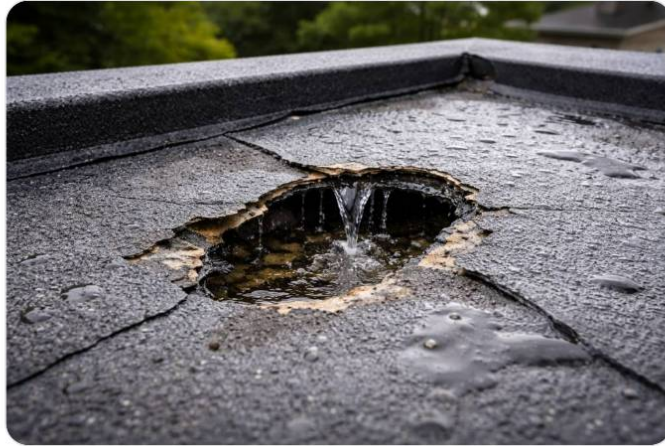
## Finding #2

Waterproofing

roof

High

During the inspection, a defect was observed in the roof waterproofing membrane. A visible opening / hole in the sealing layer was identified, which may allow rainwater to penetrate the roof structure. Such a defect can lead to water intrusion, moisture damage to the roof assembly, and possible deterioration of interior ceiling materials if not repaired.

Repair Instructions: It is recommended that a qualified roofing contractor repair the damaged waterproofing area. The repair should include cleaning the affected section, sealing the opening with an appropriate waterproofing material, and verifying that the surrounding waterproofing layer is intact to prevent future leaks.
